**Professional Engineer's Statement
Everett Smelter Cleanup, 2000-2001**

Washington Department of Ecology Everett Smelter Site 2000-2001 Cleanup

Details of Cleanup Activities

Address:
328 Skyline Drive
Everett, WA 98201

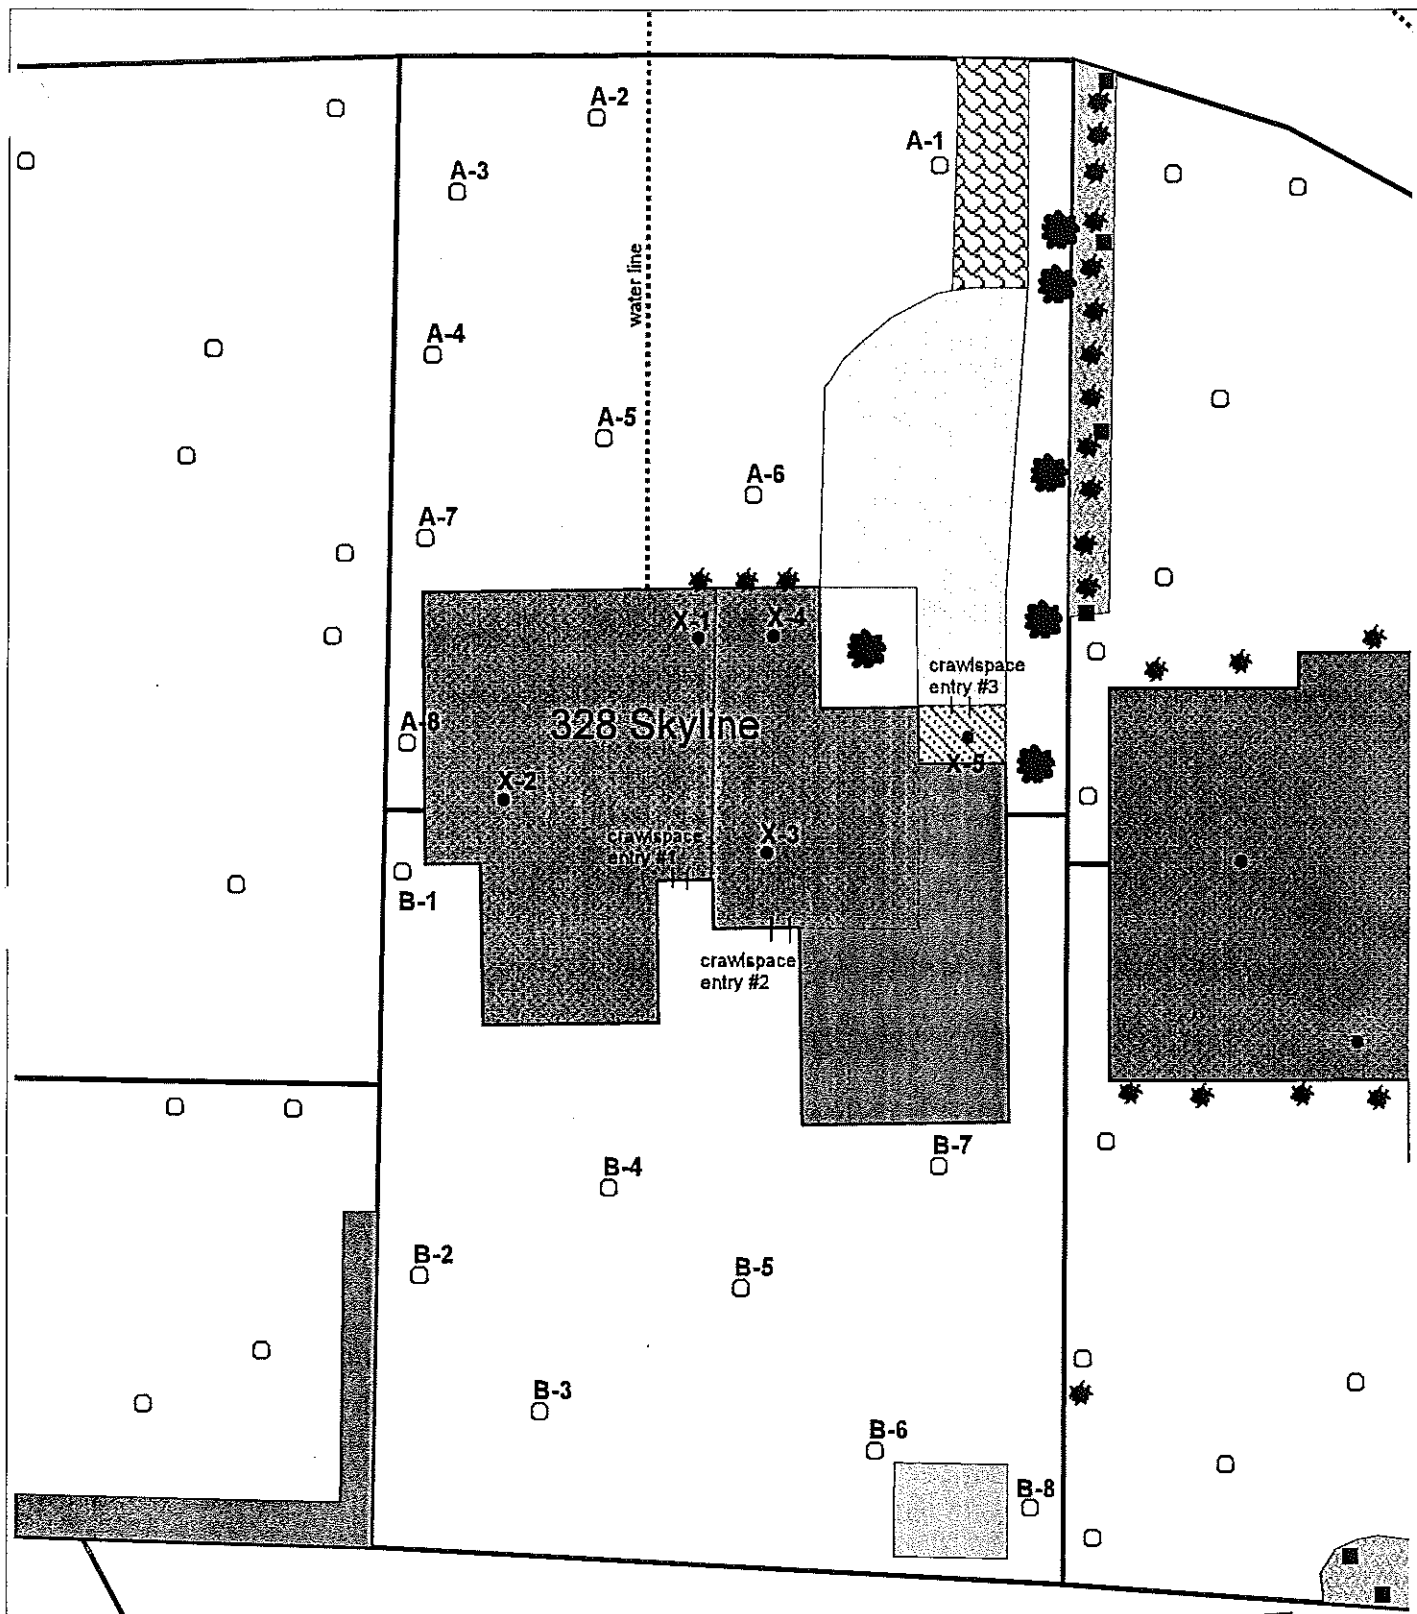
328 Skyline

This property was divided by Ecology into two Decision Units, A and B, as shown on the attached map, for purposes of pre-cleanup sampling and decision-making regarding the depth to which excavation was required. The following is a summary of the work done in the remediation of the property within each of the decision units.
